Metal Failures and Corrosion

Case Study 1

Identifying Root Cause of Pipe Rupture Provides Safer Work Environment

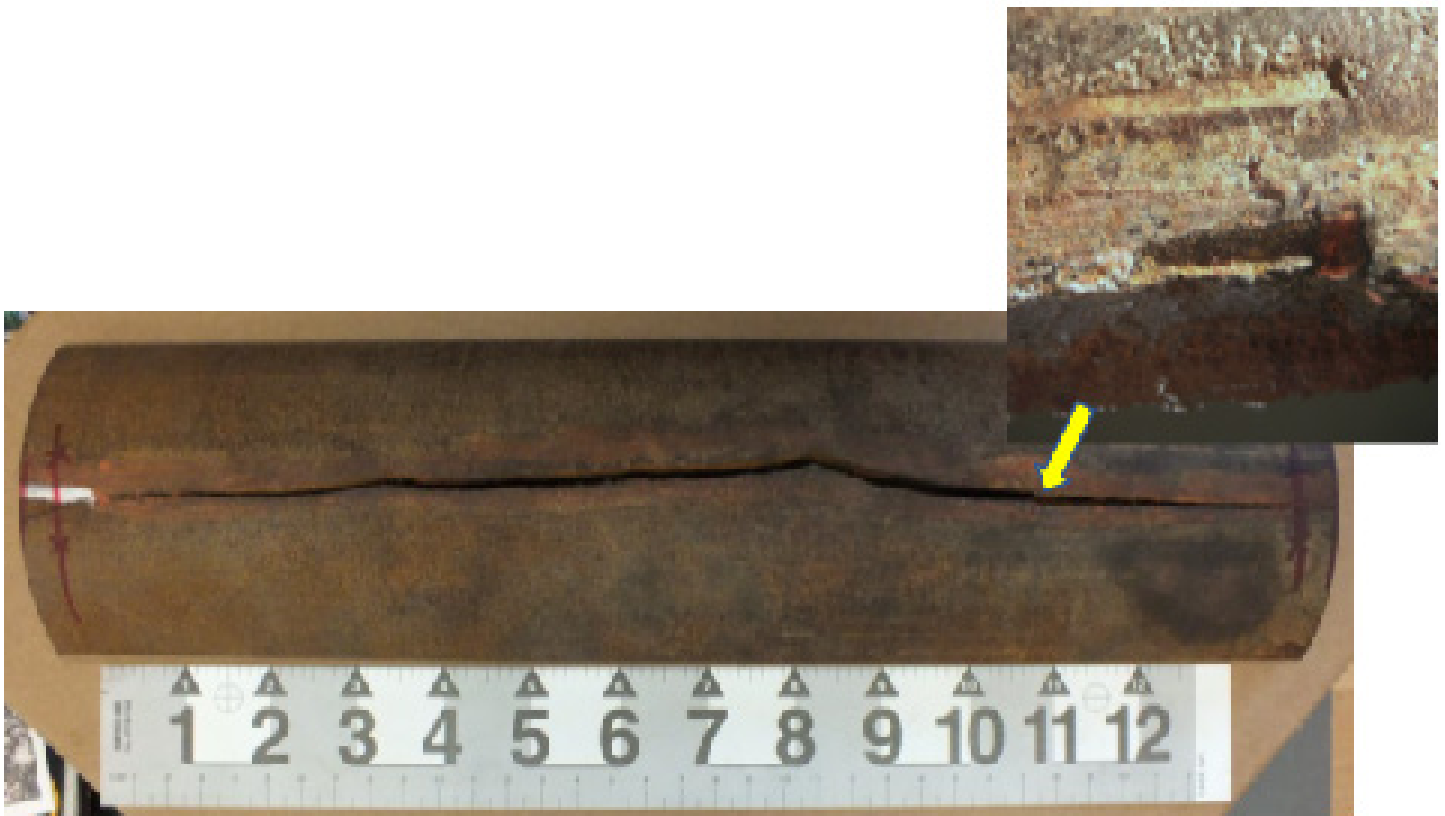
Optical and scanning electron microscopic examination of a section of pipe that ruptured during a routine hydrostatic pressurization test indicated that the rupture initiated at a plunge mark attributed to the jaws of a tightening tool. Personnel were retrained to adequately tighten sections of pipe without damaging the exterior of the pipe.

Figure: Photo of ruptured drill pipe (Insert: Magnified image of tool marks that initiated the rupture.) (RJLG image)

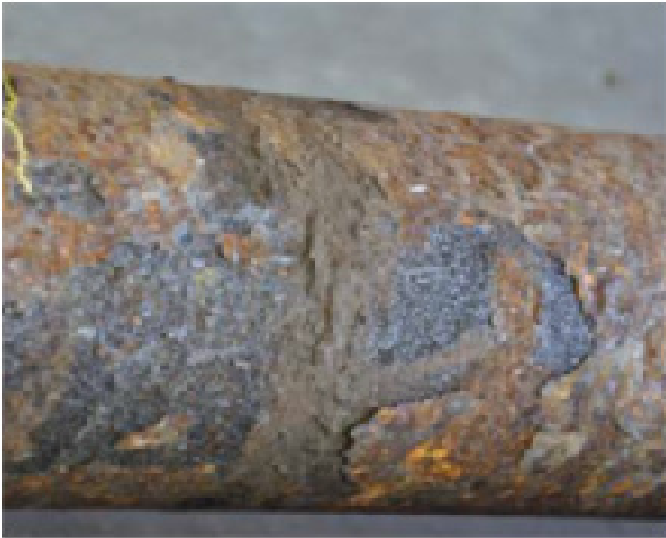
Figure: External pipe corrosion (RJLG photo)

Rapid loss of pipe wall thickness caused a drilling company to remove it from service sooner than expected. Scanning electron microscope images and energy dispersive spectroscopic provided evidence that the loss of wall thickness was caused by chloride corrosion of the exterior surface of the pipe.

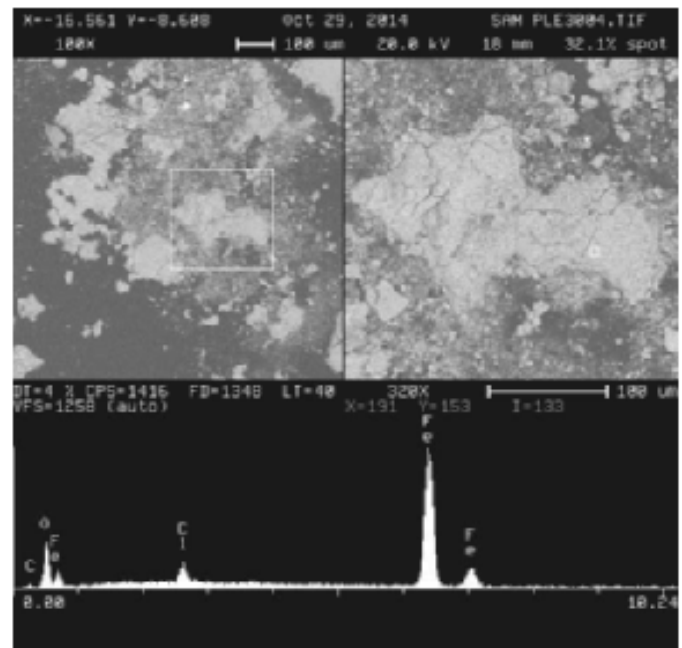
Scanning electron microscope image and energy dispersive x-ray spectrum of the of pipe corrosion products (RJLG image)
