Alkali-Silica Reaction

An RJ Lee Group Materials Insight Article

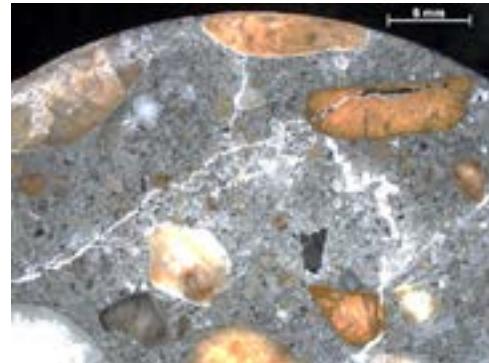
Figure 1. Reflected light micrograph of ASR-affected concrete, showing gel-filled microcracks in the cement paste and aggregate particles.⁶

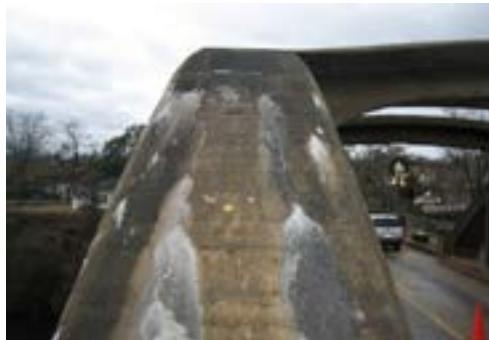
Figure 2. ASR-affected Bibb Graves Bridge in Wetumpka, Alabama, showing cracking and gel exudation features.

Diagnosis of ASR typically begins with visual inspection prompted by the presence of characteristic surface features, such as macro-cracking, gel exudation and staining along the cracks, closing of expansion joints, and even localized crushing (blowups) in pavements. Cracking in reinforced concrete is typically aligned preferentially with the primary reinforcement (Fig 2), while in unrestrained plain concrete the cracking is more random and commonly referred to as map cracking (Fig 3). Many of these visual features can also be caused by other deterioration mechanisms such as drying shrinkage, freezing-and-thawing, and delayed ettringite formation (DEF), or a combination of mechanisms that may include ASR. Therefore, visual inspection in the field must be supplemented by laboratory analyses, including concrete petrography, to determine the cause(s) of the concrete deterioration.

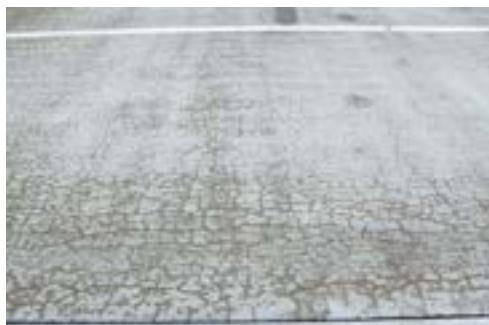
Figure 3. Example of map cracking in unreinforced concrete airfield pavement.

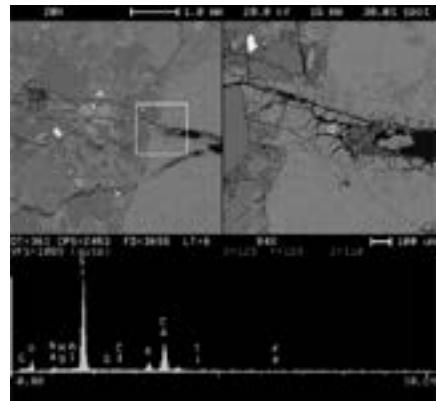
Figure 4. SEM imagery of fresh ASR gel with a "cracked mud" texture at the mouth of a crack in an aggregate particle, with EDS point spectrum showing the presence of sodium (Na), potassium (K), and silicon (Si) in the gel.

Petrographic examination of concrete core samples (ASTM C856) and Scanning Electron Microscopy (SEM) analysis (ASTM C1723) can be used to identify the presence and extent of ASR. SEM analysis is particularly useful in positively identifying the presence of ASR gel. The gel has a characteristic texture resembling cracked, dried mud (Fig 4). The reaction

starts within a cracked aggregate and propagates into the cement paste. Energy dispersive x-ray spectroscopy (EDS) is combined with SEM analysis (SEM-EDS) to determine the elemental composition of ASR gel, which is primarily silicon, with lesser amounts of calcium and traces of potassium and sodium (Fig 4). Fresh, or recently formed, gel is relatively high in silicon, potassium, and sodium. Over time, calcium ions from the pore solution will replace sodium and potassium in the gel, and the gel morphology changes. Characterizing ASR gel is important because the presence of fresh gel can be an indication that swelling and cracking will continue; aged, calcium-rich gels have less swelling potential and may indicate the reaction is complete. The result of these analyses can guide engineering decisions about the management of ASR-affected structures.
