RJ Lee Group Columbia Basin Analytical Laboratories

A Columbia Basin College - RJ Lee Group Public/Private Partnership

Asbestos Analysis Services

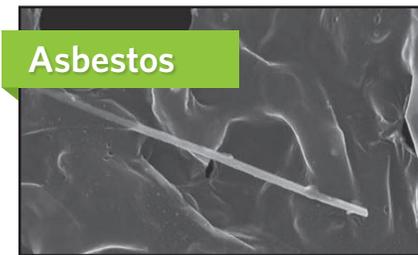
This asbestos amphibole fiber (about $7 \times 0.15 \mu\text{m}$) is embedded in the filter matrix. The "hair-like" appearance and parallel sides appear to be smooth and somewhat rounded, with no evidence of cleavage surfaces. The absence of fracture surfaces indicate the fiber developed into this shape naturally.

Correct identification and classification of asbestos are critical factors for many modern environmental issues. Particle morphology (shape and size), elemental composition (chemistry or EDS spectrum), and crystal structure (SAED pattern) are used to properly identify minerals. Once identified as an asbestiform mineral, it is important to determine whether or not the particle is, in fact, asbestos. Rather than simply relying on aspect ratio alone, close examination of the particle's morphological features, such as whether the particle has parallel sides, and fracture or cleavage surfaces, provides more complete information for analysis.

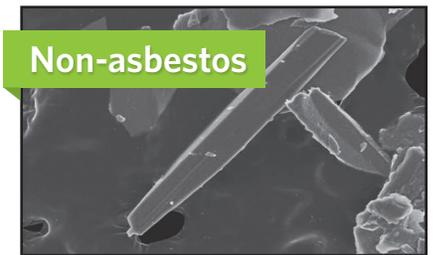
Non-asbestos amphibole particles like the one above ($11 \times 1.25 \mu\text{m}$) are often misidentified and classified as asbestos. Notice that the particle does not have parallel sides or irregular termination at the ends. The visible fracture surfaces indicate that the particle was broken to this shape rather than forming this way naturally.
