Compressor Station Support

Case Study 1

Methanol Determined in High Pressure Natural Gas

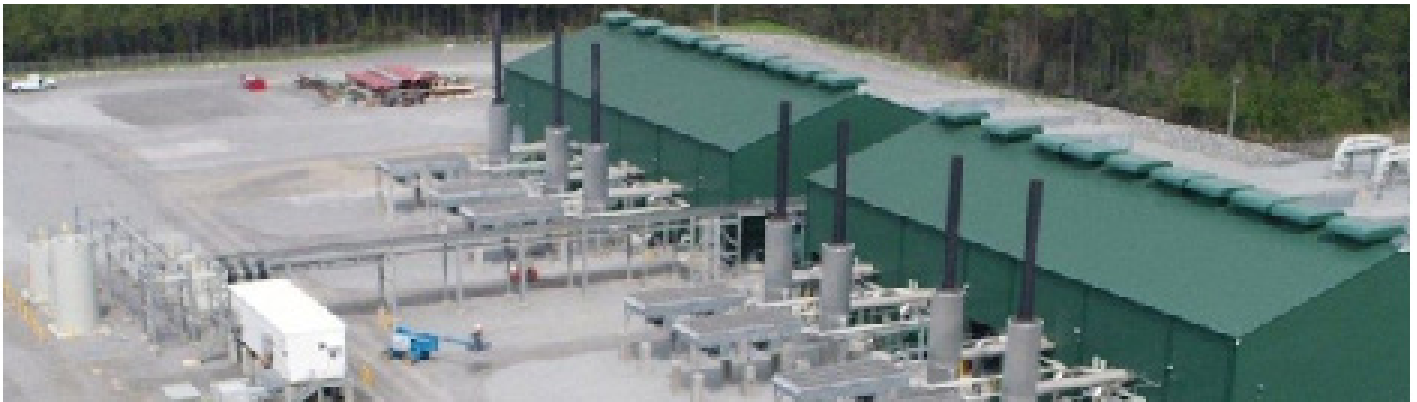
Figure: Natural gas compressor station

A midstream company needed to determine the concentration of methanol in gas collected from the high and low pressure sides of natural gas compressors as part of a hydrate inhibitor evaluation. A custom apparatus was constructed to prevent condensation of methanol when the pressure of natural gas was reduced from 800 psi to ambient pressure. Determination of the methanol was completed by gas chromatography.

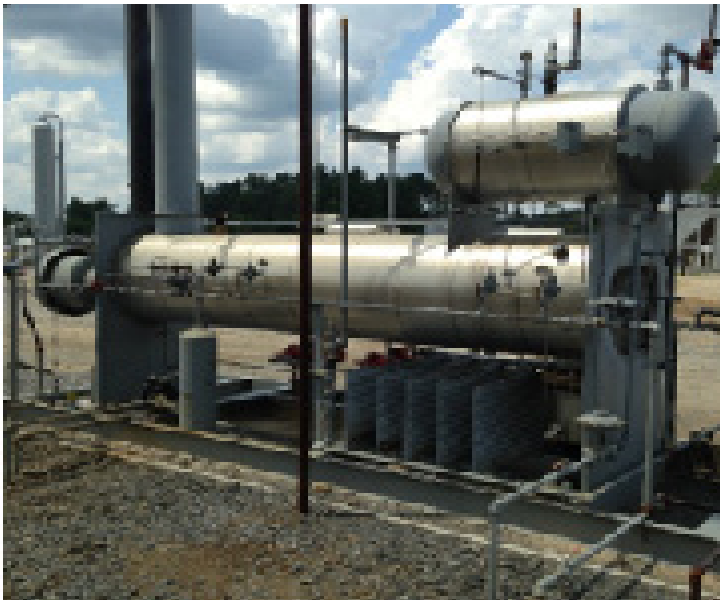
Figure: Gas Glycol Dehydration System

Triethylene glycol (TEG) in gas dehydrators is slowly oxidized by repeated exposure to water and high temperature. Performance degrades and corrosion increases as the TEG oxidizes, so spent TEG is replaced with fresh TEG, often on a time schedule. However, the rate of oxidation varies from dehydrator-to-dehydrator, causing the TEG in some dehydrators to be replaced too often when a conservative change interval is used. Conversely, if the TEG is not changed before it degrades, organic acids formed by oxidation and accumulated chlorides from produced water begin to attack the dehydrator metallurgy. One solution is to change the TEG based on condition rather than on a time schedule.

TEG samples from a series of gas dehydrators was analyzed on a periodic basis. The condition of the TEG was assessed by monitoring a number of parameters including pH, TDS, and the concentrations of chloride and sulfate. Metal concentrations were measured to determine when the TEG degradation had progressed to a point that corrosion was beginning to attack the metallurgy. Changing the TEG based on its condition increased TEG service life and decreased dehydrator corrosion, resulting in considerable savings compared to time-based TEG replacement.
