Environmental Stress Cracking in Plastics

An RJ Lee Group Materials Insights Article

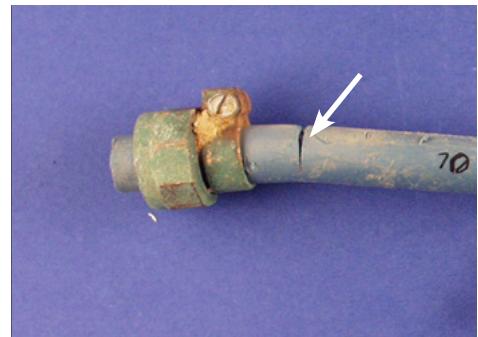
Figure 1. Photograph depicting one of the connections exhibiting a crack (arrowed) in the top of a bend resulting from installation.

The conditions leading to this mode of failure can be elusive and many times will not be obvious, even to the trained eye. The rate and severity of material response to ESC will be dictated by the service environment and the material involved, and leak-before-break conditions can occur rather than the dramatic catastrophic fracture described above¹⁻². One such instance occurred in a newly installed community water distribution system employing olefin-based polymer lines. After installation, a sanitizing agent was used to clean and disinfect the lines. The agent was not subsequently flushed and remained in the internal environment of the lines. This was not a problem in and of itself; however, contrary to installation instructions, the installation practices had created "goose neck" curves in the lines at the entry locations to many of the residences. This geometry created tensile stressed regions on the inside surfaces of some of the lines. Figure 1 depicts one of the connections that had cracked as a result of the bend which imparted a tensile stress during installation.

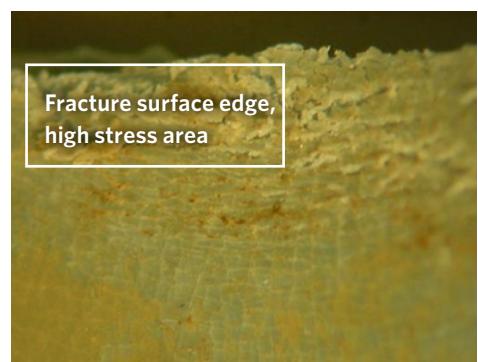
These tensile stressed locations reacted with the environment by exhibiting general degradation, strain whitening and families of stress cracks in these bent regions, resulting in ultimate failure and leaking as shown in Figure 2.

Figure 2. Photograph depicting the ID surface of one of the supply lines. Note indications of polymer degradation and cracking most severe adjacent to fracture surface and high stress area.

The tensile stress is what caused the polymer to crack as exposed to the internal environment; outside the bend regions, the third ingredient (tensile stress) was not sufficiently present and therefore no cracking occurred. Figures 2 and 3 depict the most severely affected zones associated with the ID surfaces and correspond to the regions influenced by the presence of sufficient tensile stress to initiate ESC.

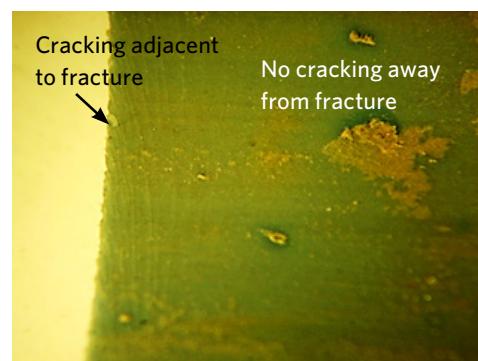
The interior diameter (ID) surfaces of the lines outside the influence of the bending tensile stress appeared relatively unaffected with no indication of alteration or problems, as observed in Figure 3.

Figure 3. Photograph depicting the ID surface of one of the supply lines. Note the family of stress cracks dissipates as function of distance from the fracture.

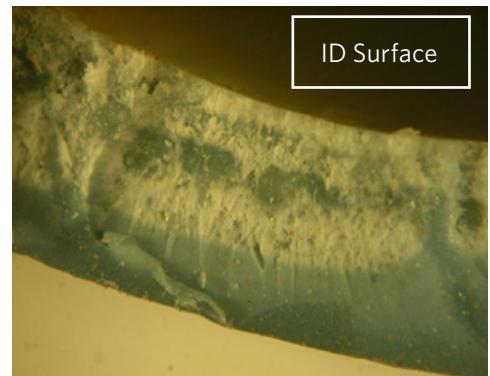
Figure 4. Photograph depicting cross sectional view of failed line on the tensile side of the line. Note most severe effect and crack initiation on ID surface in the tensile zone of the line.
