# Iron Sulfides and Concrete

An RJ Lee Group Materials Insight Article

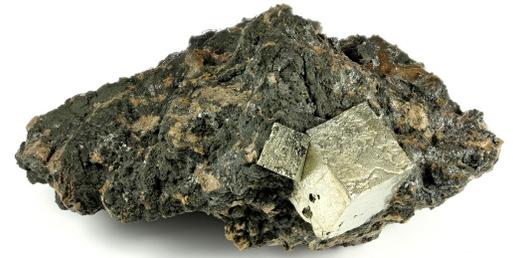
Figure 1. Pyrite cubic crystal on bedrock from Norway.

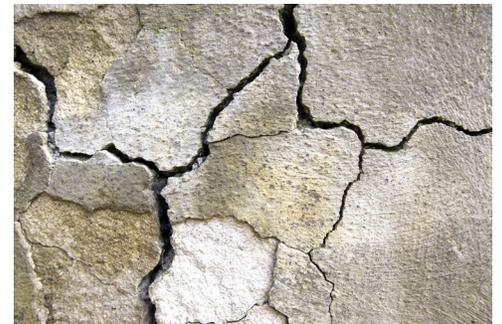
Figure 2. Cracked concrete foundation wall.

Pyrrhotite oxidizes more readily in concrete than pyrite. Reactions between the resulting sulfuric acid and the cement paste may form secondary sulfate minerals causing significant expansion and cracking of the concrete. In the most severe cases, alteration of the cement paste results in weakening and loss of structural integrity of the concrete. The use of pyrrhotite-bearing aggregates has been found to be the root cause of extensive damage to thousands of homes and commercial buildings in Eastern Connecticut<sup>2</sup> and Quebec, Canada<sup>3-4</sup>.

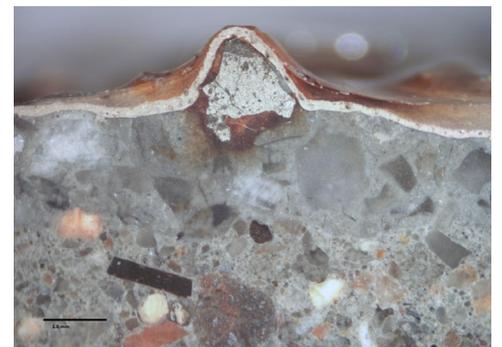
Figure 3. Stereo-optical micrograph of a polished cross section of painted stucco with rust staining showing pyrite sand grain near the surface.

Iron sulfides are common in a variety of rock types and therefore may be present in aggregates used in concrete. Pyrite is the most stable iron sulfide mineral, but can still oxidize near the surface of concrete and stucco, leading to unsightly staining and pop-outs. In good-quality dense concrete, aggregate containing small amounts of pyrite can be successfully used without affecting durability of the structure.

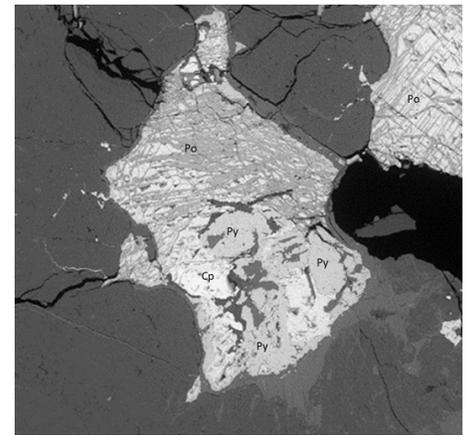
Figure 4. Backscattered electron (BSE) image of polished thin section of aggregate cracked due to oxidation of pyrrhotite. This aggregate has three different iron sulfide minerals present and in association with each other. The pyrrhotite (Po) can be seen in this image as the bright striated material. The striations are due to oxidation resulting in formation of iron hydroxides. The more stable pyrite (Py) and chalcocopyrite (Cp) have not shown reaction.

A number of factors affect the rate and potential for damage due to oxidation of pyrrhotite, including the concentration of mineral, the concrete quality, the crystallographic mineral form, association with other iron sulfides, host rock mineralogy<sup>5</sup>, and the environment. The role of these factors and their effects on oxidation rate are not fully understood.
